Ashbourne SHD, Ashbourne, Co. Meath

Preliminary Design Stage Quality Audit

200059-DBFL-TR-XX-RP-C-0001

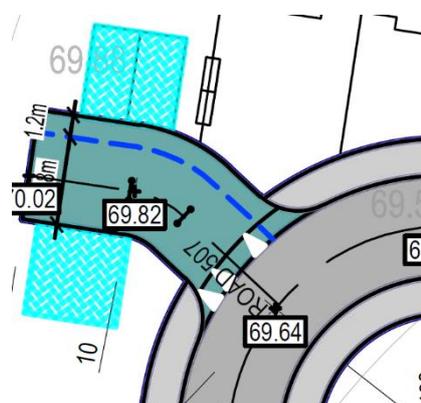
Problem G1 – Ramped access to home zones

A number of locations within the development provide a ramp into the “Home Zone” residential areas. In some locations, the ramp appears to be situated in the direct line of travel for the footpath and crossing for pedestrians, as shown in the example image. Therefore, there is a level difference and crossfall at where pedestrians will want to cross the road. This may lead to trips and falls by pedestrians, in particular, visually impaired pedestrians.

It is recommended that the footpath be diverted slightly away from the ramp and tactile paving provided so as to indicate to pedestrians, in particular, vulnerable road users, where to cross.

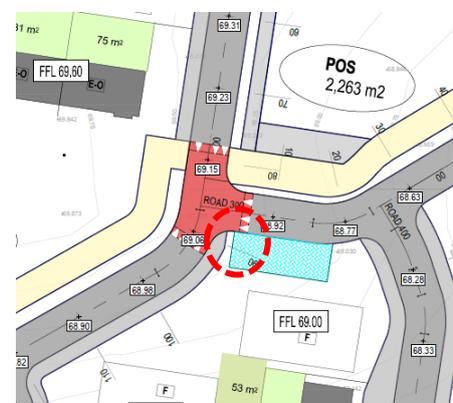
Problem S1 –Raised Table blocking parking space

The ramp of the raised table is currently blocking the perpendicular parking space adjacent to it, leading to level differences when accessing the space. This could result in unsafe vehicle manoeuvres when accessing/egressing the parking space and could lead to vehicles colliding with other parked vehicles.

It is recommended that the parking spaces are moved so that they are not blocked by the ramp within the raised table.

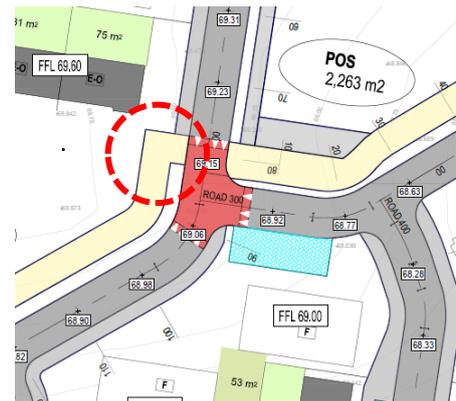
Problem S2 – Shared path transitions

The shared path at the raised table crossing appears to have a sharp 90° transition to the crossing. This could lead to difficult negotiating for cyclists to cross, possibly leading to cyclists falling from the bicycle.

It is recommended that transitions within the shared path are less severe and employ an appropriate radius for cyclists to negotiate easily and with comfort.

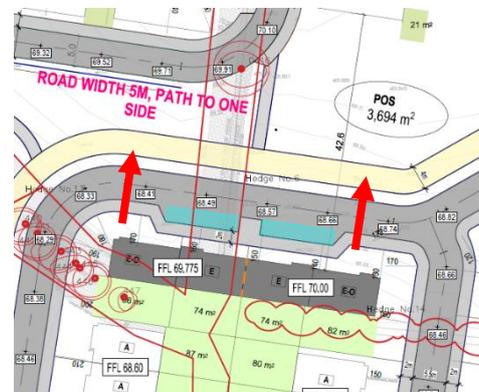
Problem S3 – Shared path buffer

The shared path appears to have a buffer between the path and the road carriageway along its length. It is unclear as to what this buffer entails and whether pedestrians/cyclists will have accessibility through this buffer area. Should the buffer be hard landscaping, this will hinder accessibility to and from the path and key travel desire lines.

It is recommended that the buffer be accessible for pedestrians and cyclists to access the shared path. Should landscaping be provided within the buffer, ensure that there are accessibility points on all key desire line locations for pedestrians and cyclists.

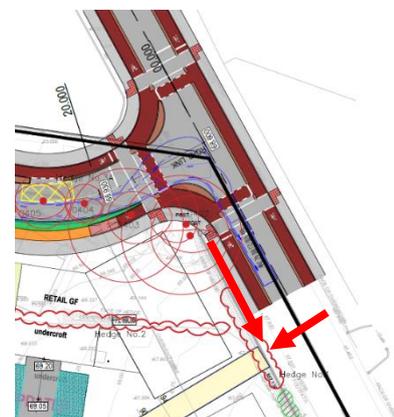
Problem S4 – Accessibility for the Shared Path from the R135

It is unclear as to how southbound cyclists travelling along the R135 (and cyclists travelling northbound from the direction of the intended shared path) will access the shared path into the development. There appears to be no formal facility to allow cyclists to travel safely between the signal-controlled junction and this path. This could lead to cyclists undertaking unsafe manoeuvres, possibly on the footpath

which may conflict with pedestrians in this location or crossing the busy R135 with no crossing allocated.

It is recommended to provide a safe connection link for cyclists travelling southbound from the proposed cycle protected junction to the shared path.

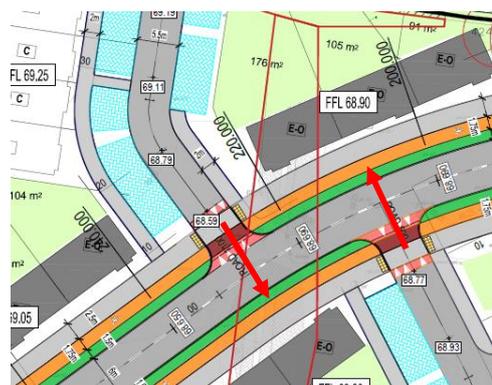
Problem S5 – Access for pedestrians and cyclists on main spine road

In a number of locations, there appears to be no access for cyclists travelling from side road junctions to the main cycle track facility along the main primary road within the development. Grass verges are located between the cycle track and the road carriageway. Similar connection issues are present for pedestrians.

Gaps within the grass verge should be provided at strategic locations for pedestrians and cyclists to access the footpaths and cycle track facilities located on the opposite side of the main spine road.

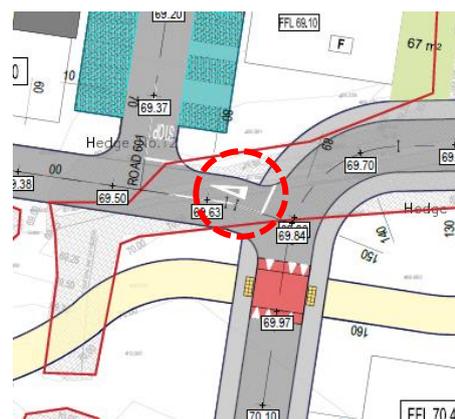
Problem S6 – Yield priority at minor junction

The minor arm of the priority junction is allocated with a yield road marking. This may give the impression to a driver that they are not required to stop at the junction before undertaking a turning movement. This could lead to collisions with other vehicles who have priority.

It is recommended that STOP road marking and appropriate signage be allocated to ensure that vehicles giving way make the appropriate stop before making their turning movement.

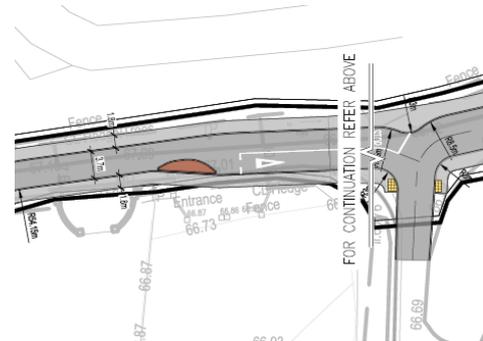
Problem S7 – Shuttle system conflict with vehicular accesses

The proposed island and road markings allocated for the shuttle system along Hickey's Lane appear to be blocking access for the residential driveways located here. This could result in accessibility issues for residents located here.

The shuttle system should be revised so as not to block residential property accesses.

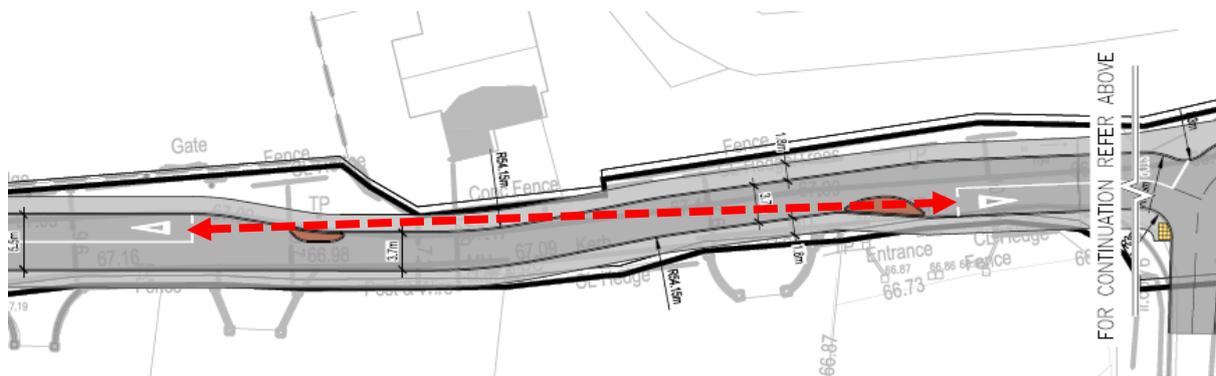
Problem S8 – Shuttle system visibility

The length of the proposed shuttle system appears long at 85m approximately. It is unclear as to the level of visibility between each end of the shuttle system. Reduced visibility could lead to head on collisions between vehicles.

Ensure that adequate sightlines are provided along this section. If sightlines are not achievable, alternative solutions could be explored.

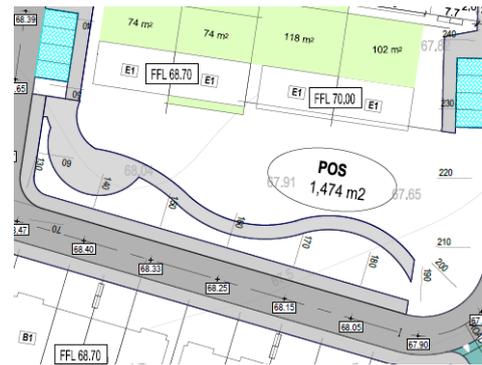
Problem S9 – Termination of footpaths

Some paths within the development appear to terminate abruptly. This could lead to accessibility issues and confusion for pedestrians, in particular, visually impaired pedestrians.

It is recommended that footpaths do not end abruptly and link together where appropriate so as to improve permeability within the development.

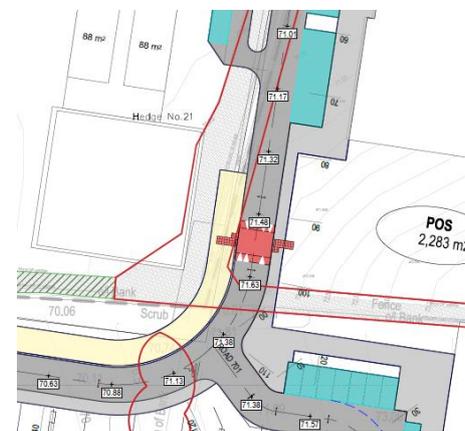
Problem S10 – Clarity on crossing type

The raised crossing located south of the reserved school site appears to be allocated as a signal-controlled crossing, however, there are no road markings to indicate to vehicles to stop at this crossing. This may lead to vehicles failing to stop while pedestrians are crossing which may result in a collision.

Road markings should be provided to indicate to drivers that they are approaching a mid-block signal-controlled crossing.

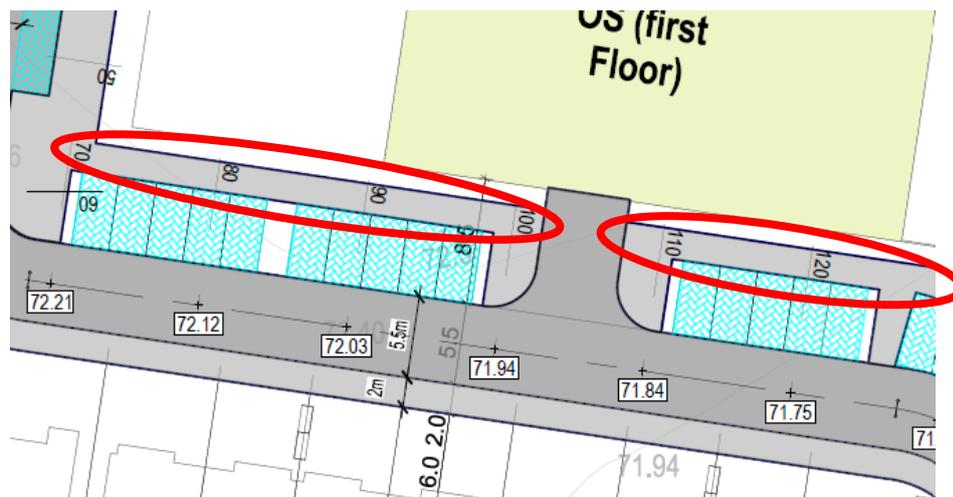
Problem S11 – Narrow footpath at parking bays

Some locations within the development appear to have narrow footpaths in locations of perpendicular parking bays. There is the possibility that vehicles could overhang the parking space into the footpath area, reducing the effective width further in these locations. This could lead to accessibility issues, in particular for wheelchair and pushchair users.

Ensure that footpaths have adequate width to comfortably accommodate vulnerable road users.
Ensure that vehicles do not overhang the footpath in these locations.

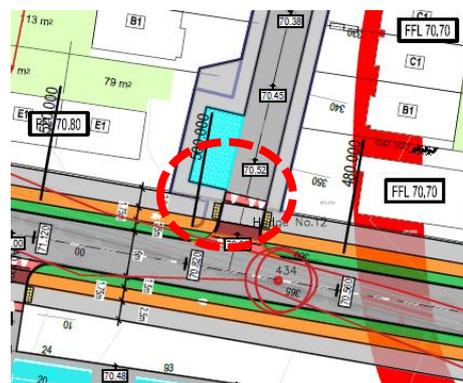
Problem S12 – Parking close to junction

There are some locations within the development where the perpendicular parking spaces are located close to a junction. There may not be sufficient distance for sightlines or reactions for drivers. There is a risk that vehicles accessing or egressing from the parking space will conflict with turning vehicles within the road carriageway, which may lead to a collision.

Relocate parking bays away from junctions so that there is adequate sighting, reaction and stopping distance between drivers accessing/egressing the parking spaces and drivers turning within the road carriageway.

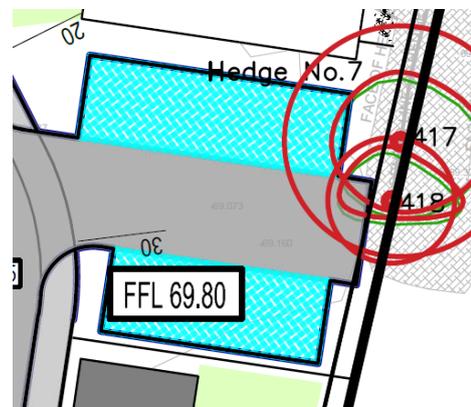
Problem S14 – Width of road for perpendicular parking spaces

In some locations, it is unclear whether sufficient width has been allocated within the road carriageway to allow a vehicle accessing / egressing from the perpendicular parking spaces. Failure to provide sufficient widths for parking, could result in vehicles clipping other parked vehicles in these locations.

Ensure that sufficient carriageway and parking bay widths are provided for vehicles accessing and egressing perpendicular parking spaces.

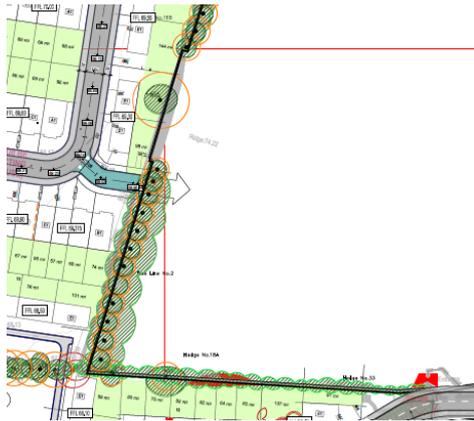
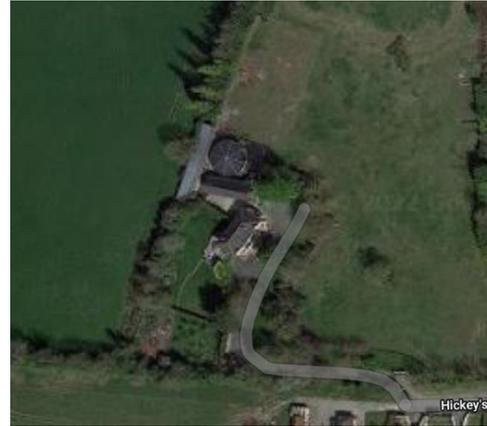
Problem S15 – Continuation of Homezone into private lands

It is noted that there is an arrow located at the homezone (on the southern end of the development) which leads into private lands. It is unclear as to the purpose of this arrow. It also appears to be conflicting with an existing residential property in this location.

Clarification is sought as to the purpose of this arrow and whether the homezone will extend into this private land at this specific location.
